A Multi-Tenant Commercial Office Building in New York City, NY. Part 2

By Martin Robinson, CMRP Level III Thermographer President, IRISS Inc.

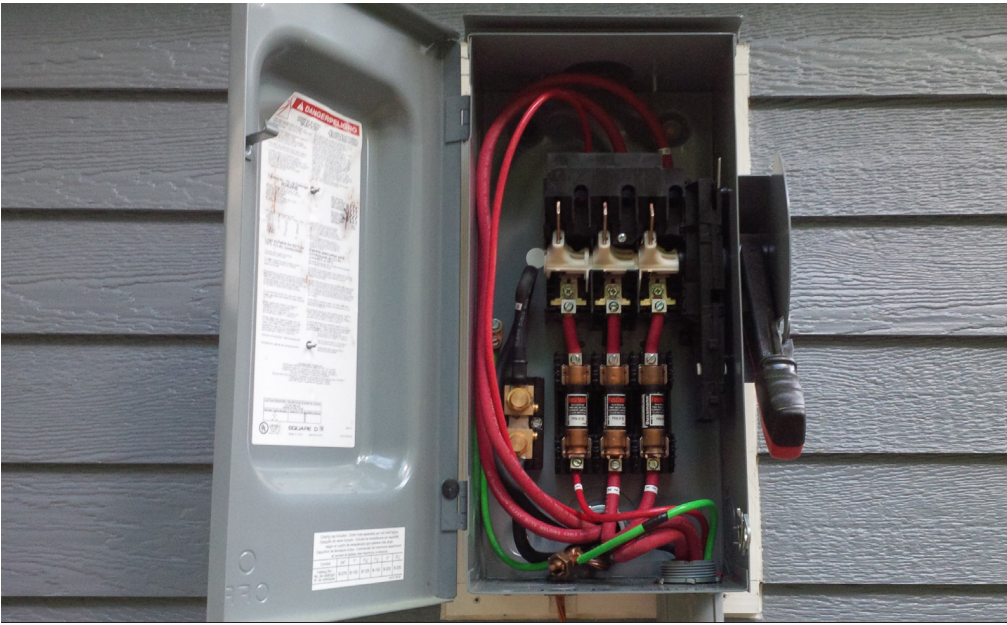
This proactive client wanted to monitor the electrical panels and disconnects in the Main Switchgear Room of the facility daily versus annually. Delta T Alert's installed on panels and disconnects in the Main Switchgear Room of this facility. The Delta T units were programmed to record temperature rise within the enclosures two times a day. This data was transmitted wirelessly to the Chief Engineer's computer for analysis and trending. On November 23, 2010, five Delta T units were installed within the facility and programmed to send the Delta T data to the Chief Engineer's computer at 10:00 am and 2:00 pm. On December 30, 2010, Lobby A/C Fuse Disconnect showed a Delta T of approximately 53°F.

Figure 1 Main Switchgear Room, Lobby A/C fuse disconnect shows an elevated Delta T of 53.2°F.

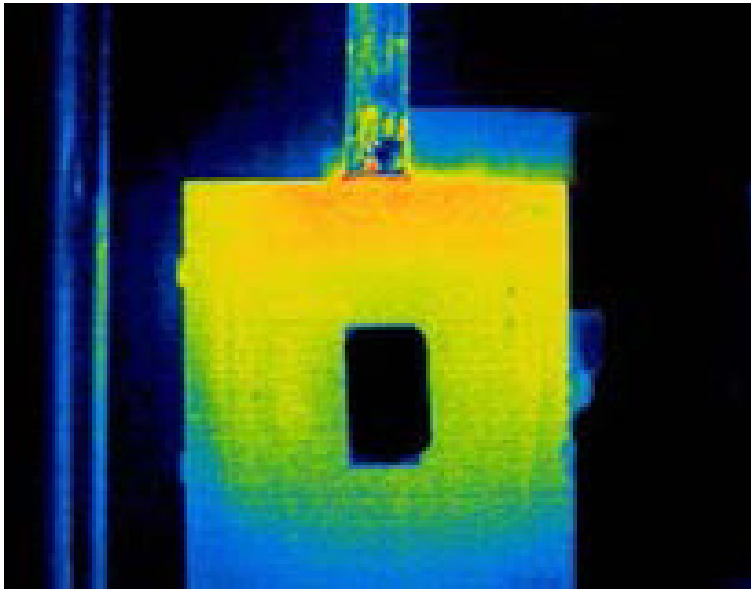
Figure 2 Thermographic image documents that this panel cover is warm.

After the Chief Engineer reviewed the Delta T Alert data, thermographic testing was conducted prior to opening the door (Figure 2). Once the disconnect door was opened and scanned, thermography results show phase's "A" and "C" fuses and fuse connections are warm. This #1 priority requires further investigation to determine cause of hot spot (Figure 3).
