A Geothermal Energy Generation Facility Embraces Infrared Polymer Window Inspections

By Dominique Capili, Spectrum Scientific Corporation (An IRISS Distributor)

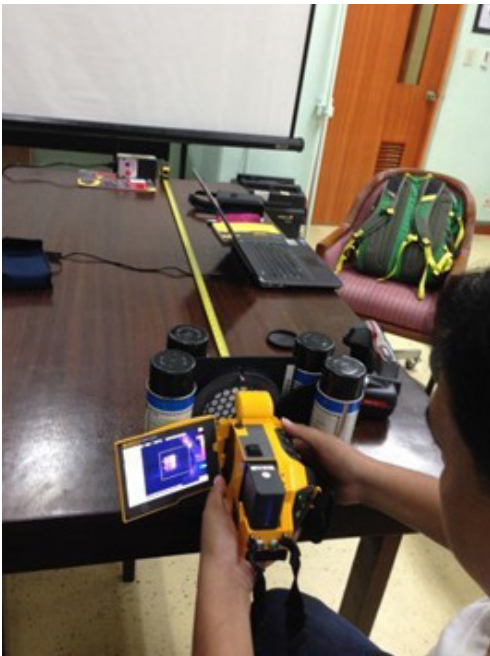
Bench Testing:

The last few days were allocated for bench testing, simulation of readings using multiple OEM IR camera types and training of personnel. The simulation of readings using the various camera types and a Black Body temperature source through the IRISS infrared polymer windows measured distance corrected ambient temperature, emissivity usage values and parameter setting on the respective devices.

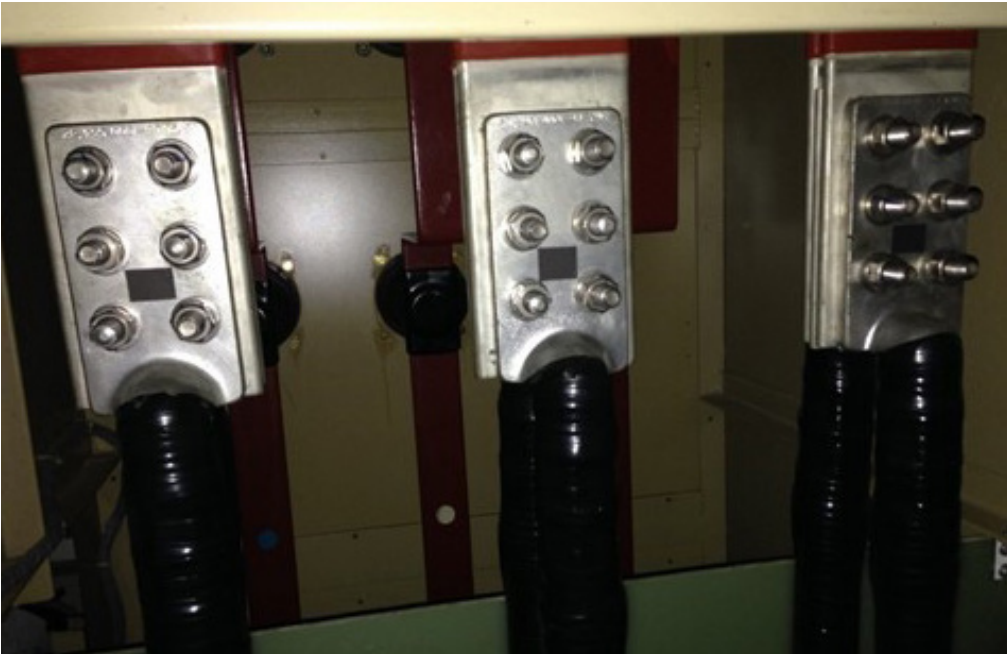
Emissivity Tape Mounting:

Where possible, connections were taped with known emissivity insulating tape. In this way, more accurate temperature readings can be taken of the target potential hot spots.
