Chilean Power Plant Implements IRISS Custom Inspection Solutions

By Hugo Pereira, VP LATAM Business Development at IRISS, Inc.

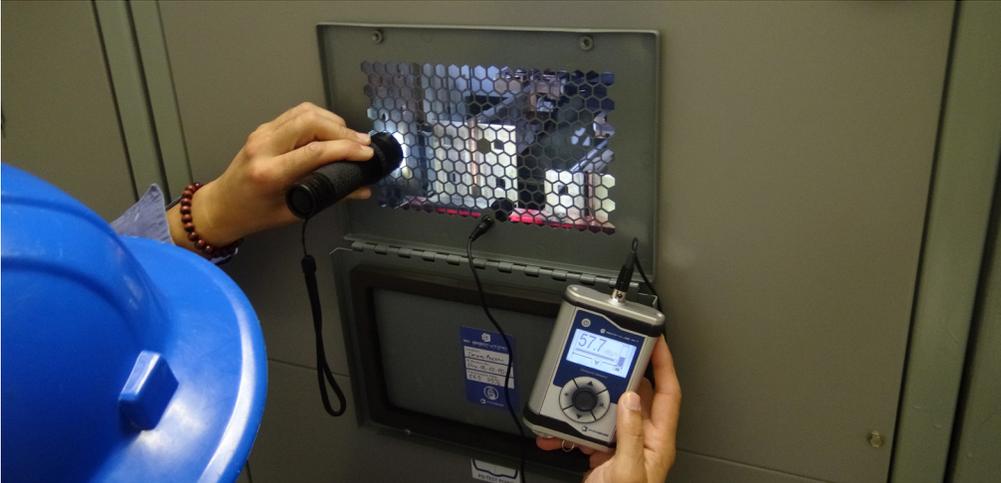
All of these units included Partial Discharge Sensors integrated in the Maintenance Inspection window that allow a handheld ultrasound detector to be plugged in and listen for signs of partial discharge within the equipment enclosure.

Custom sized windows were chosen to reduce the total installation cost and ensure that a single window would be sufficiently sized to see all the possible targets of interest in the equipment.

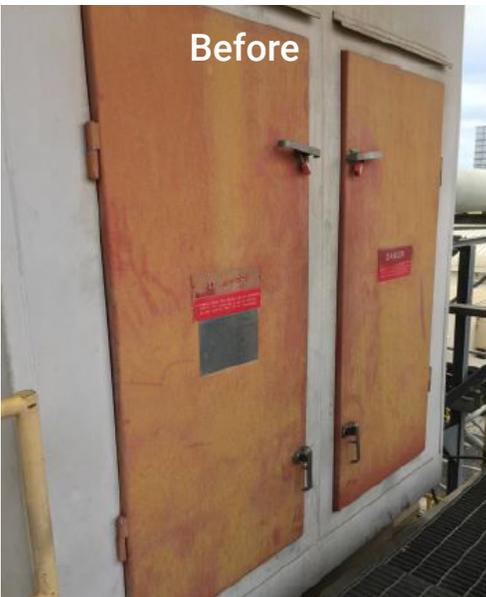
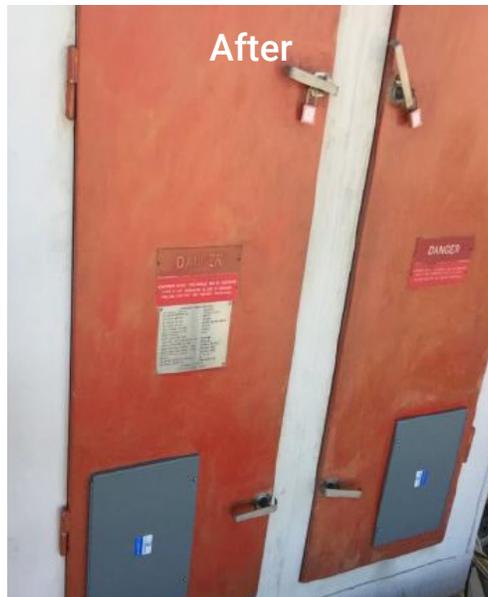
20"x16" CAP-ENV Windows installed on Generator Panels

- 4pc. CAP-ENV Custom size 20" x 16" with Partial Discharge Sensor for 2 Generators
- 4pc. CAP-CT Custom size 20" x 7" with Partial Discharge Sensor for critical Motor and Fan panels
- 6pc. CAP-ENV Custom size 12" x 8.5" with Partial Discharge Sensor for other Generators
- 1pc. CAP-ENV Custom size 24" x 10" with Partial Discharge Sensor for Excitation Transformer

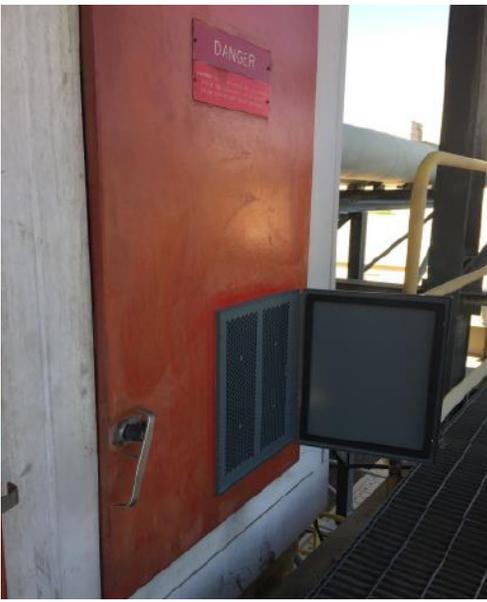
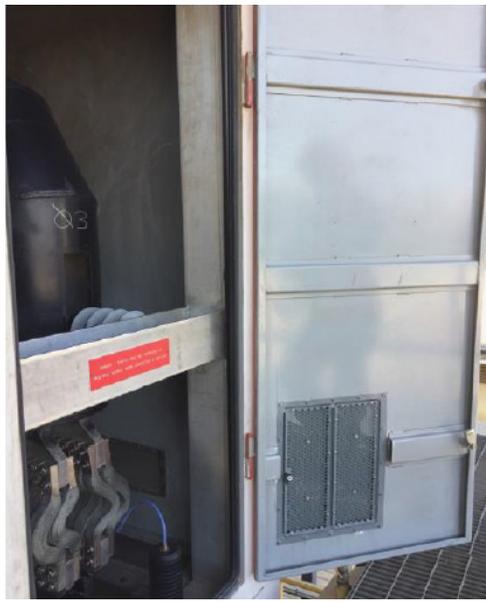
Windows were installed on lower portion of doors to give viewing of Incoming Connections

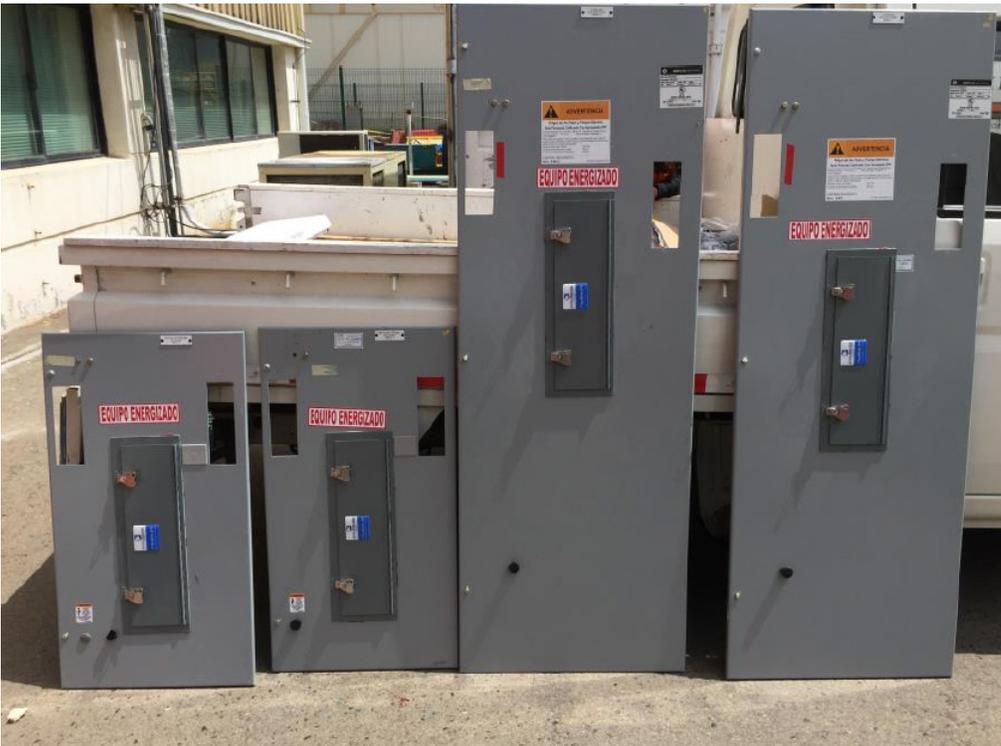
Windows installed on Equipment Doors before remounting to the Switchgear

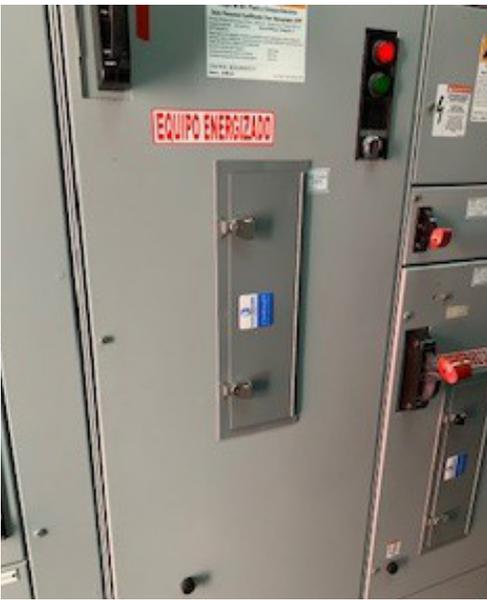
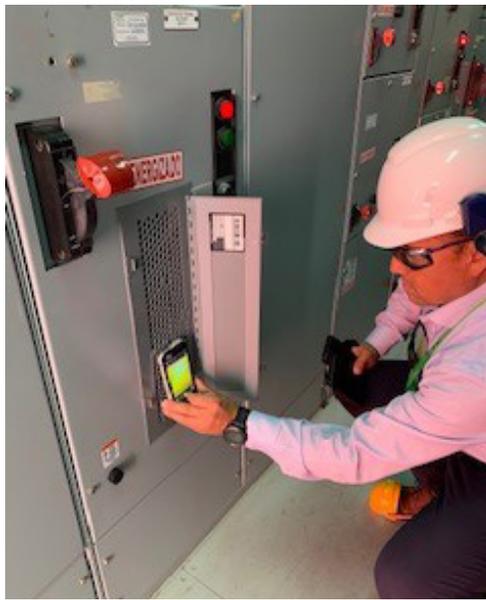
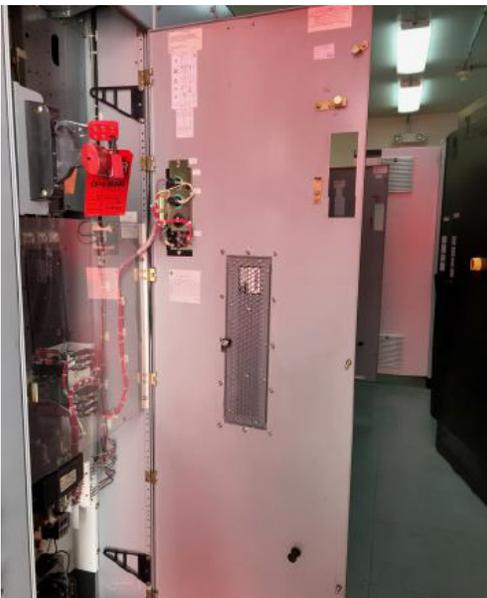
Switchgear door remounted with custom 20"x7" CAP-CT window fitted
