Middle East State Owned Utility Company, Fault Prevented

Overview:

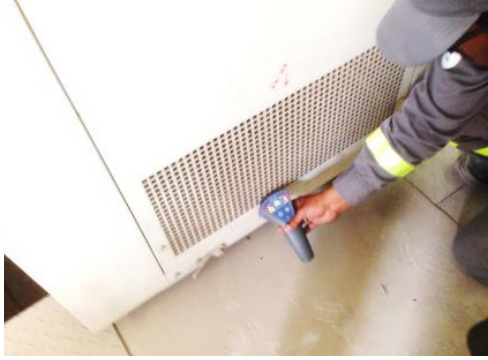
The Sonus PD is a dual transducer PD detector for Switchgear. The instrument detects TEV signals generated by internal discharge, as well as acoustic discharge generated by surface tracking or corona. The Sonus PD is a quick and simple tool for PD detection; enabling regular asset assessment by all substation staff.

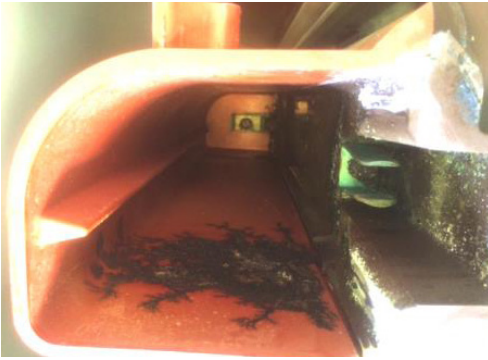
Following the detection of Partial Discharge activity, an offline investigation was conducted on the asset to locate the discharging component. Clear evidence of extensive burning and carbonisation was seen on the Fuse Holder within the Fuse Chamber, as shown in the Figure 1 and Figure 2 below.

Figure 1 Extensive carbonisation on the inside surface of the fuse chamber.

Following the investigation, the defective components were replaced. On-line PD tests were carried out again and the discharge had ceased. It was clear from the extent of damage that the unit would have failed had it not been detected.

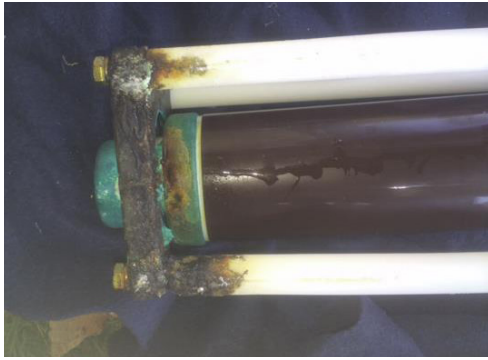
Figure 2 Evidence of water damage that would have led to the discharge activity.
